**Flood Control Project Maintenance
Levee Inspections**

Fall 2012 Levee Maintenance Deficiency Summary Report

Yolo County Service Area 6

Waterway			Bank	Unit Miles
Unit No. 01 Right Bank of Sacramento River at Knights Landing			Right	5.97
	Spring (March - May)	Summer (June - August)	(September - November) Fall	Winter (December - February)
Unit Maintenance Rating (Fall Only)			U	
Date of Inspection	04/17/2012 - 04/17/2012		11/21/2012 - 11/21/2012	
DWR Inspector	John Williamson		John Williamson	
Accompanied By	Regina Espinosa Yolo County		Regina Espinosa Yolo County	
	Chris Starke Yolo County		Chris Starke Yolo County

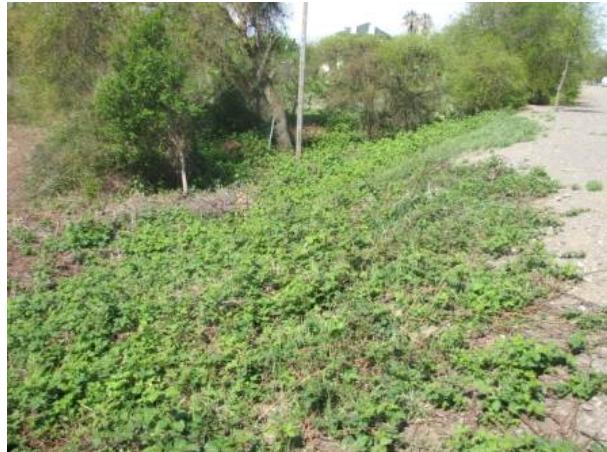
johngw_f_20120911_279.jpg

The berries have been grazed down but not killed.
Photo taken spring 2012.

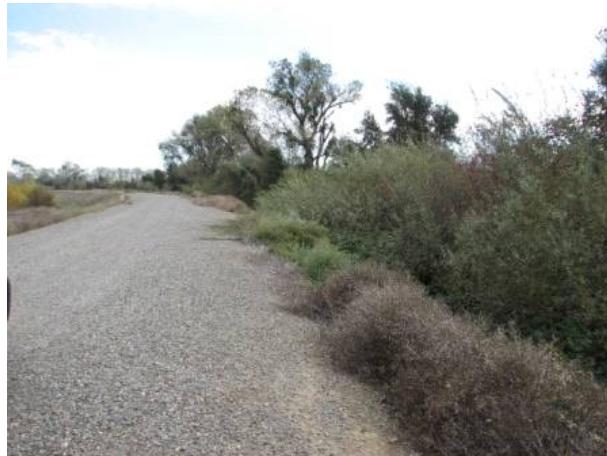
johngw_f_20120911_302.jpg

The vegetation completely blocks the view of the levee slope. Fall 2011

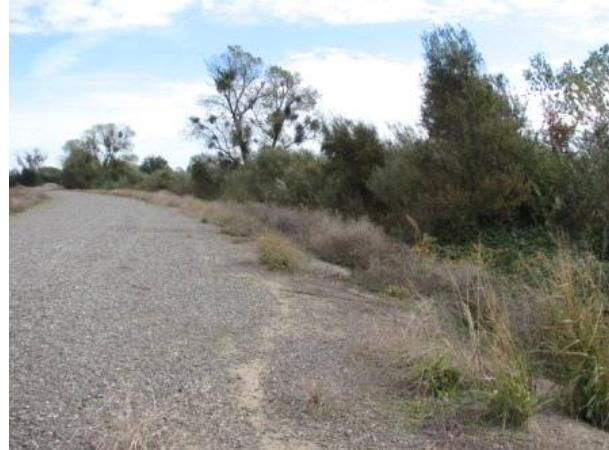
johngw_f_20120911_301.jpg

The vegetation blocks the view of the levee slope.
Fall 2011

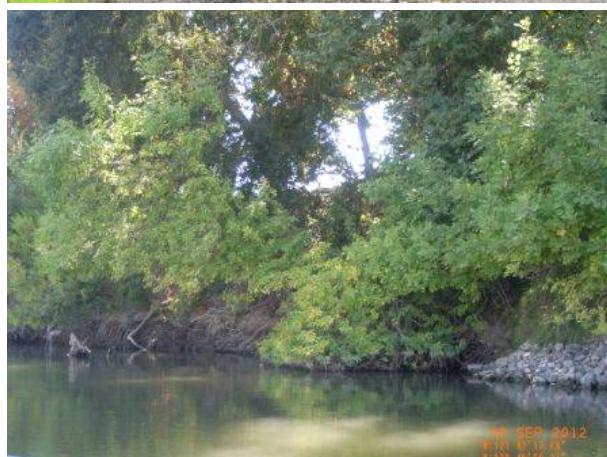
Levee Mile Report Line	39
Start Levee Mile	3.18
End Levee Mile	3.28
Location	Water Side
Category	Supplemental
Item	USACE Erosion Survey
USACE 2012 Photo #1	
USACE2012_SAC_86-9_R_1.jpg

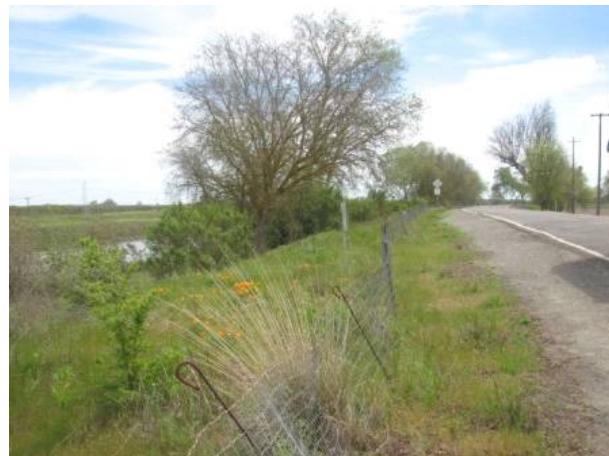
Levee Mile Report Line	44
Start Levee Mile	4.31
End Levee Mile	4.57
Location	Water Side
Category	Earthen Levee
Item	Vegetation
Another view of the site.	johngw_f_20120911_319.jpg

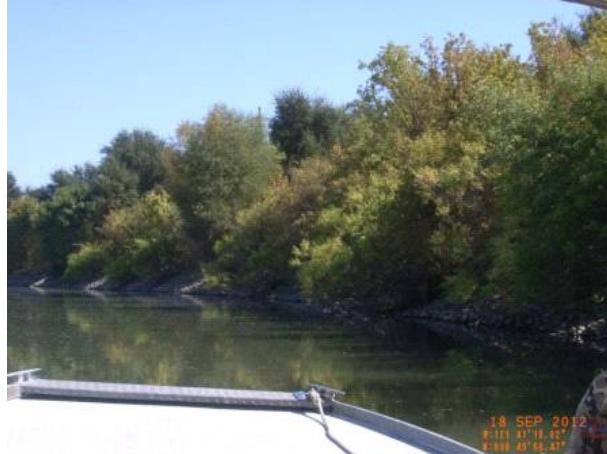
USACE 2012 Photo #1

45	4.66	4.86	Supplemental USACE Erosion Survey	WS M Ma	Inspector Comments: 2009 - Erosion into the levee toe. Some cobbles have been dumped into the erosion pockets. 2010 - Old cobble site starting to unravel. 2012: No observed change. [2012 Site ID: SAC_85-4_R]		38.763486 ° -121.687567 °	38.763313 ° -121.684038 °	4	DWR ID:	
46	5.60	5.65	Earthen Levee	Encroachments	LS A/W En	BU : Building	38.759620 ° -121.673903 °	38.759412 ° -121.673167 °	1	DWR ID: DWR_NA0022_01_s_2012_1	
47	5.77	5.86	Supplemental USACE Erosion Survey	WS M Ma	Inspector Comments: 2006 - Approximately 18 to 20 ft of bank near levee at the corner of the levee and the Freemont Weir. Vertical bank with undercutting/mass failure. 2007 - Staked at top of bank for monitoring. 2011 - Site has become significantly worse with more of the toe and lower bank eroded. Many trees have fallen since last year. 2012: Site looks worse with more erosion around trees. [2012 Site ID: SAC_83-9_R]		38.758877 ° -121.669365 °	38.759390 ° -121.667500 °	5	DWR ID:

Levee Mile Report Line	45
Start Levee Mile	4.66
End Levee Mile	4.86
Location	Water Side
Category	Supplemental
Item	USACE Erosion Survey

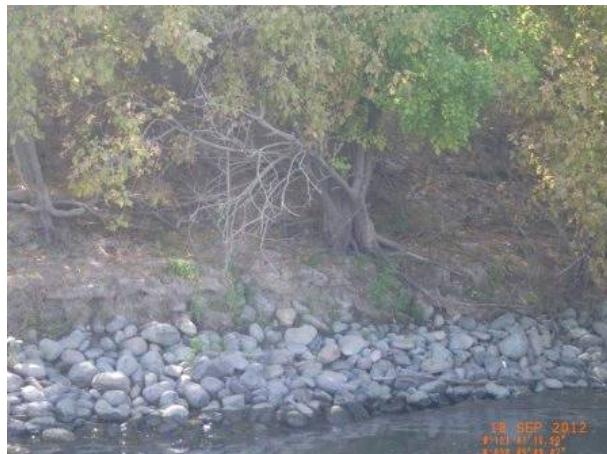
USACE 2012 Photo #2

Levee Mile Report Line	45
Start Levee Mile	4.66
End Levee Mile	4.86
Location	Water Side
Category	Supplemental
Item	USACE Erosion Survey

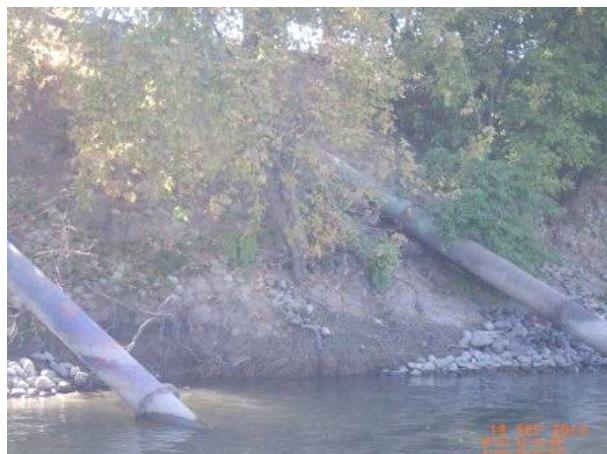
USACE 2012 Photo #3

Levee Mile Report Line	45
Start Levee Mile	4.66
End Levee Mile	4.86
Location	Water Side
Category	Supplemental
Item	USACE Erosion Survey

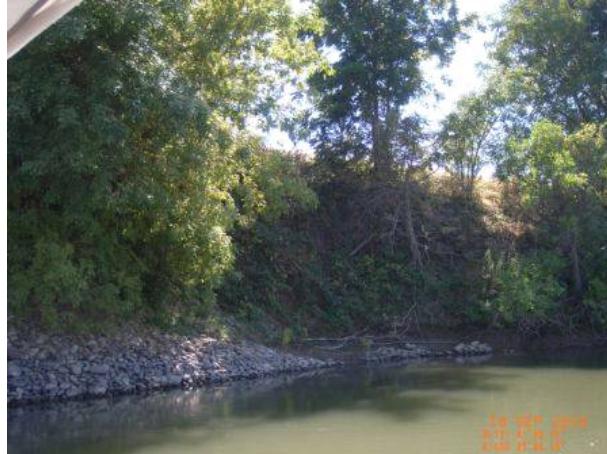
USACE 2012 Photo #4

Levee Mile Report Line	45
Start Levee Mile	4.66
End Levee Mile	4.86
Location	Water Side
Category	Supplemental
Item	USACE Erosion Survey
